Map 24: Thackley - Buck Wood

Character of the Area

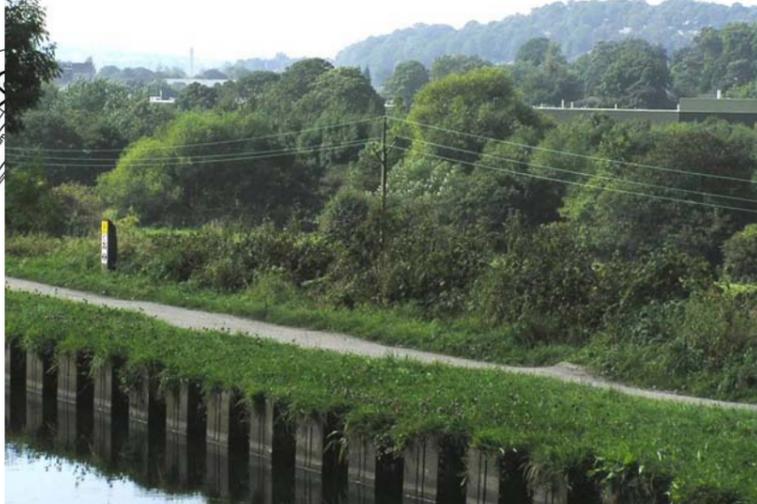
Metal piling along the canal bank near Buck Mill Lane.

Along this section, the towpath is fairly broad and is surfaced with packed white gravel, with rugged, clean grass verges to either side. While the eastern bank of the canal has a natural edge to both field and woodland, the western bank is lined with metallic piling.

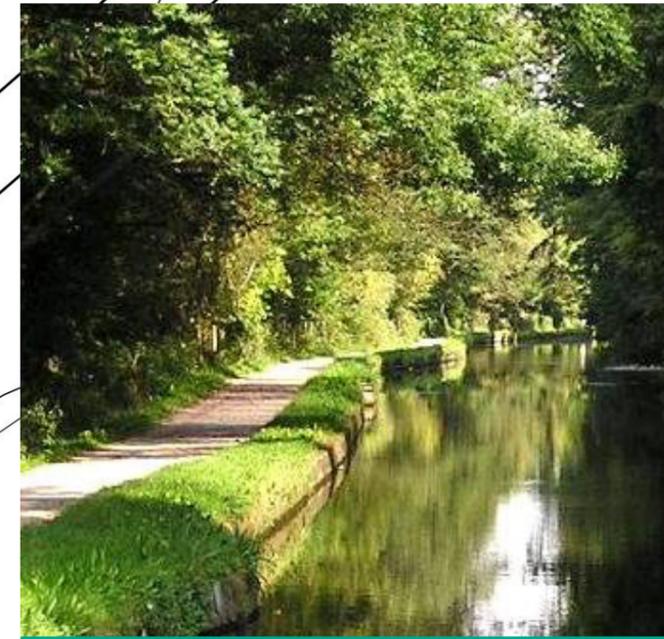
Vista of the canal as it passes through Buck Wood.

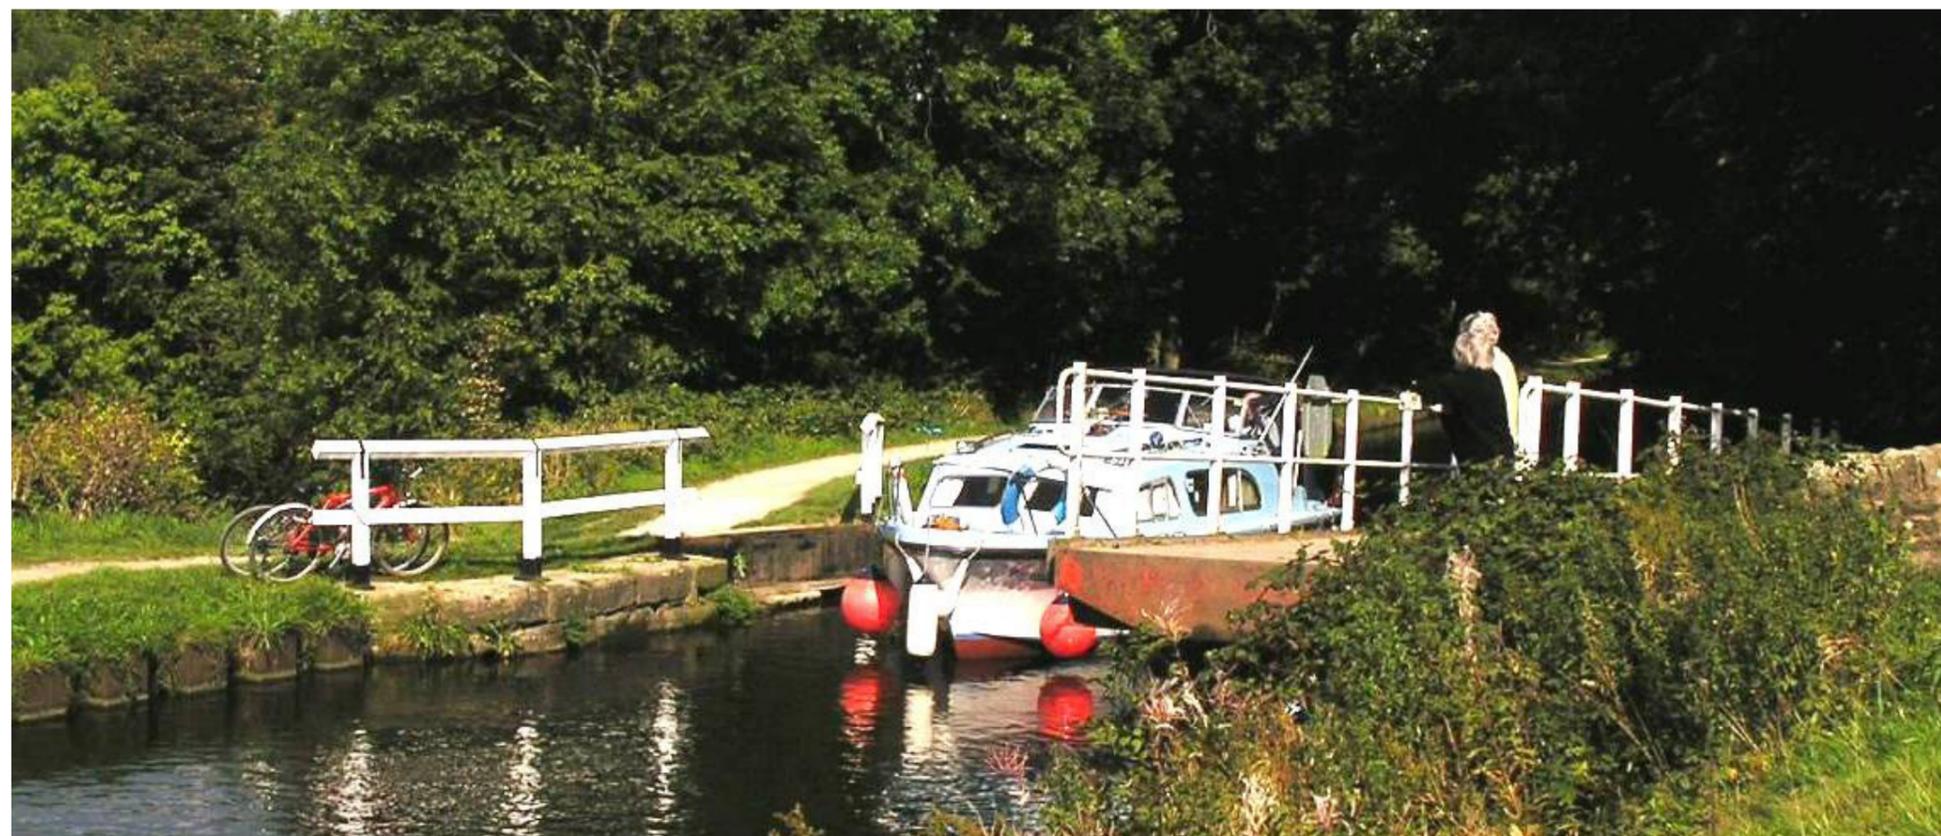
Bottom: Pleasurecraft passing through the manually operated Buck Mill Swing Bridge on the edge of the leafy Buck Woods.

1. Buck Mill Swing Bridge (211): This manually opened swing bridge has a tarmac surface edged with timber to which modern style painted steel railings are attached. At the east end is the balance beam, but the surface underneath is bare earth. The space over which the bridge swings when open is covered with rushes. The banks at the bridge are stone with stone copings. At the northern side there are painted traditional timber railings with square posts with iron feet and diamond handrails and guardrails. This bridge is on a track between Thackley and Baildon.

- ▶ The modern appearance and neglected state of Buck Mill Swing Bridge.
- ▶ The lack of traditional window details to the unlisted buildings.
